Monthly dig report for members of Leicestershire Industrial History Society and Swannington Heritage Trust.

Engine House near Califat Shaft - Excavation 2006-2016 - Ventilation Fan / Winding Drum Pit

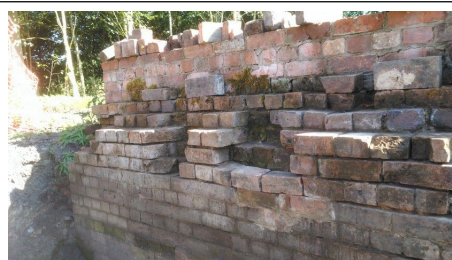
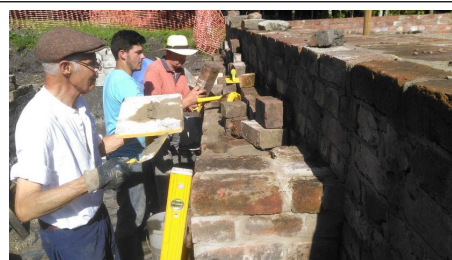
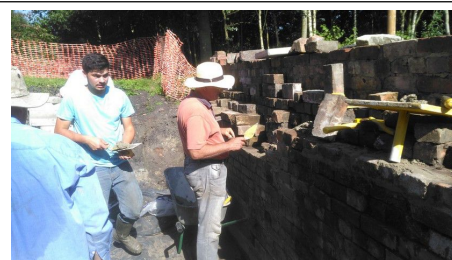
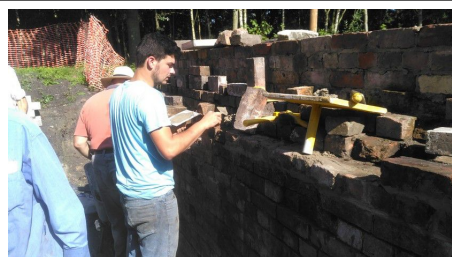
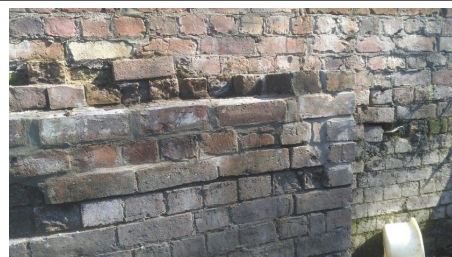
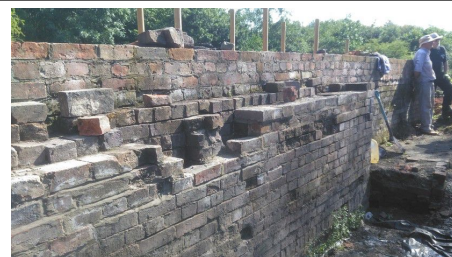
The stabilisation of the east wall of the pit (the engine house side) continued. A lime rich cement mortar was used as the lime helps prevent damage to the bricks and the cement provides the strength. Stabilisation will be the prime focus of the diggers in October as it would be good to finish stabilising the wall before the winter frost.

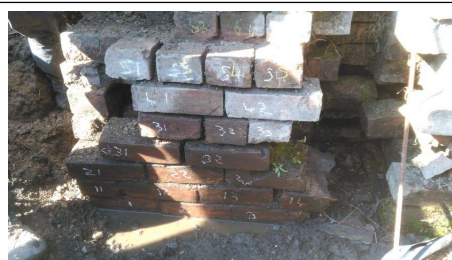
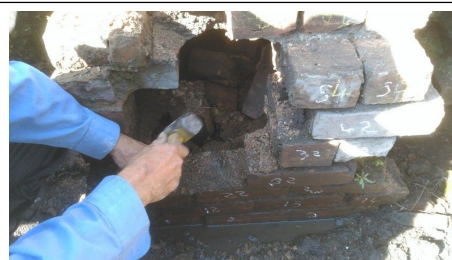
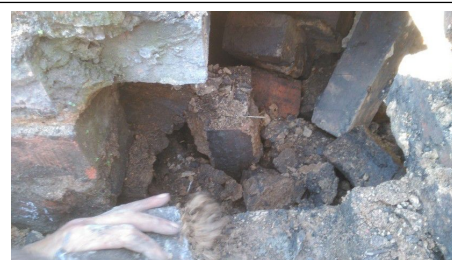
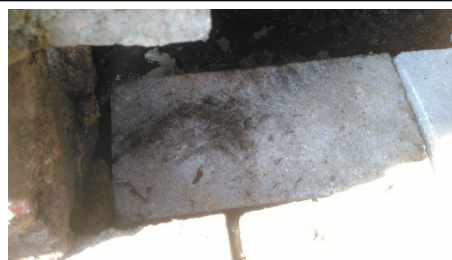
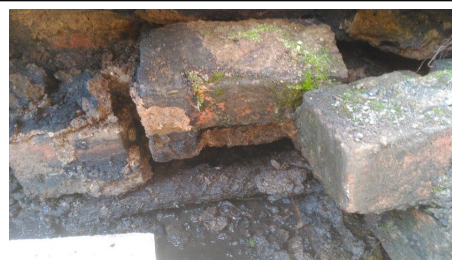
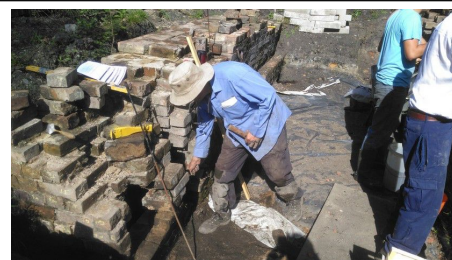
The south west corner of the west wall is being rebuilt as some of the bricks were loose. The bricks were numbered with chalk so that each brick will be replaced in the correct position and orientation during the stabilisation. The bottom left photo shows cement blocks being used inside the hole to strengthen the structure. The bottom middle photo shows the original wood support.

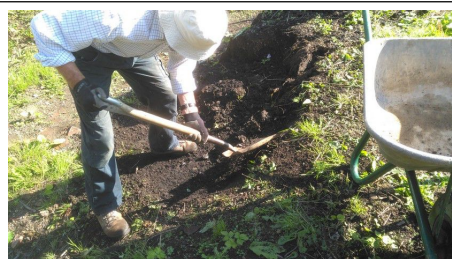
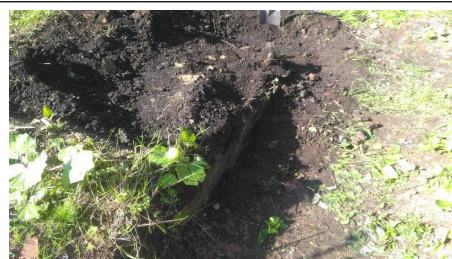
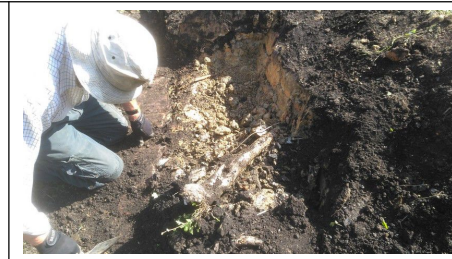
Material to the south (pond side) of the exposed chimney tunnel was removed so that rainwater from the ridge of soil will sink into the ground before reaching the bricks. The clay was taken to line the bank of the centenary wood pond.

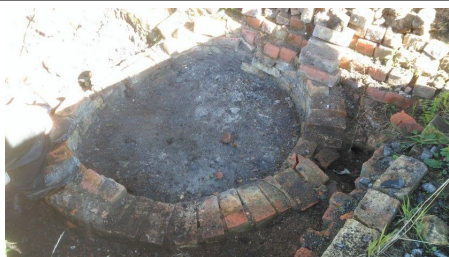
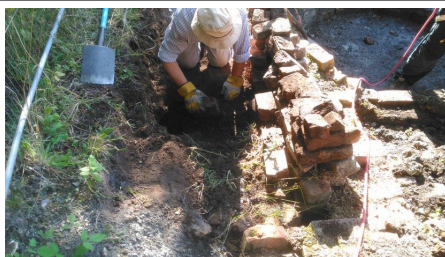
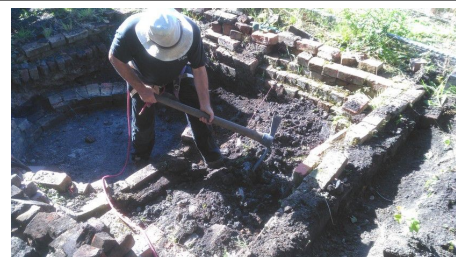
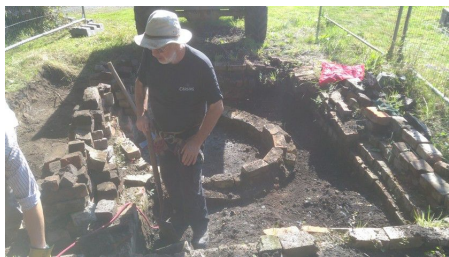
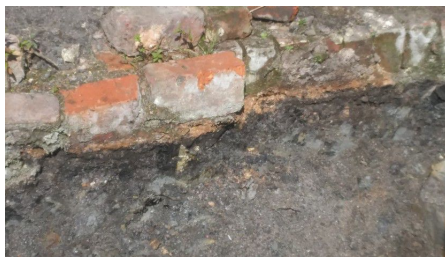
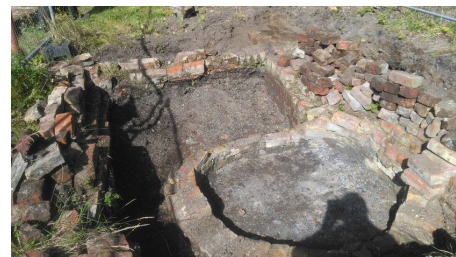
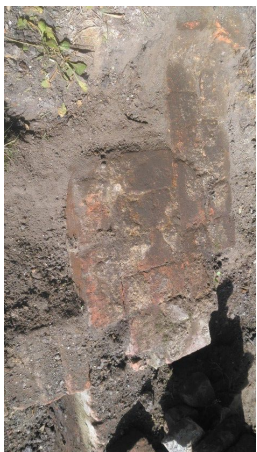
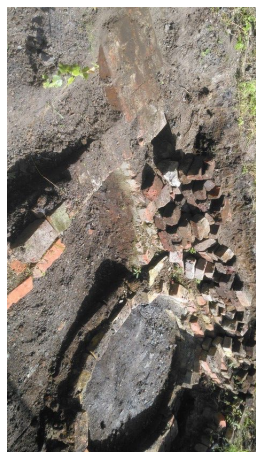
One digger (harnessed to a tree) excavated the area inside the shaft and the rectangular building surrounding the shaft. Other diggers exposed the outside of the rectangular building. The heras fencing was replaced at end of the session.

The north wall of the rectangle was built on clay, without the foundations that support the other walls.

At the north east corner a wide spur juts out to the north. This needs further investigation.
