Fantail Drive Mechanism

Replacing the Curb Drive Pinion

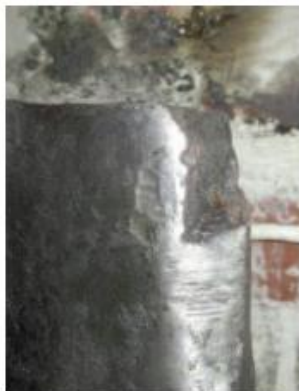
In 2015 the Mill Team noticed that the pinion was damaged. It had only lasted five years. Sadly, they tied off the fantail to stop them turning and removed the curb drive pinion. The team felt that a different engineering solution was needed.

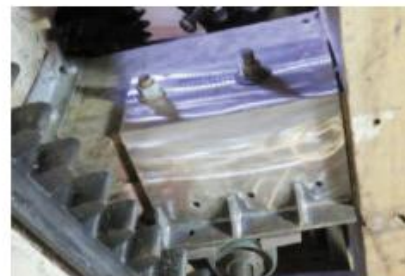
The coach bolts on the pinion shaft lower bearing bracket had sheared or were loose. The team had to fabricate a beam supporting bracket and fit studs through the wooden beam to hold the bearing in place.

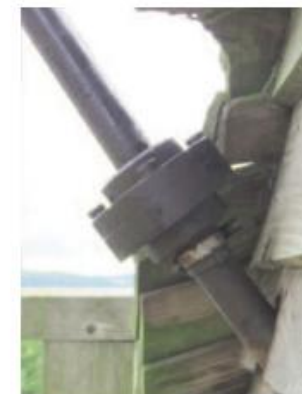
The exterior drive shaft meets the internal drive shaft just outside the cap roof. They were held together by a muff coupling which had failed and was very difficult to remove as it had to be cut off.

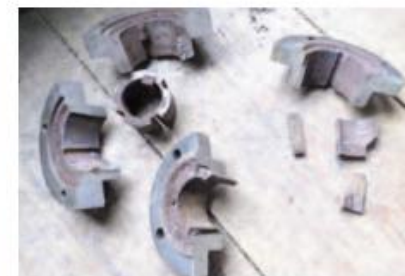
Once removed the reason for the failure was apparent as it was in several pieces.

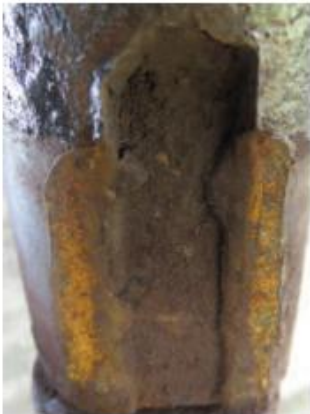
The keyway in the exterior drive shaft was damaged and the shaft sections were out of alignment. A new muff coupling had to be made and fitted.
