This photo report is produced by the dig team. It is given to Swannington Heritage Trust and Leicestershire Industrial History Society to use, publish and distribute as if they own the copyright. Thanks to Bill for the first couple of photos. January dig attended by six diggers.

Califat Engine House Area

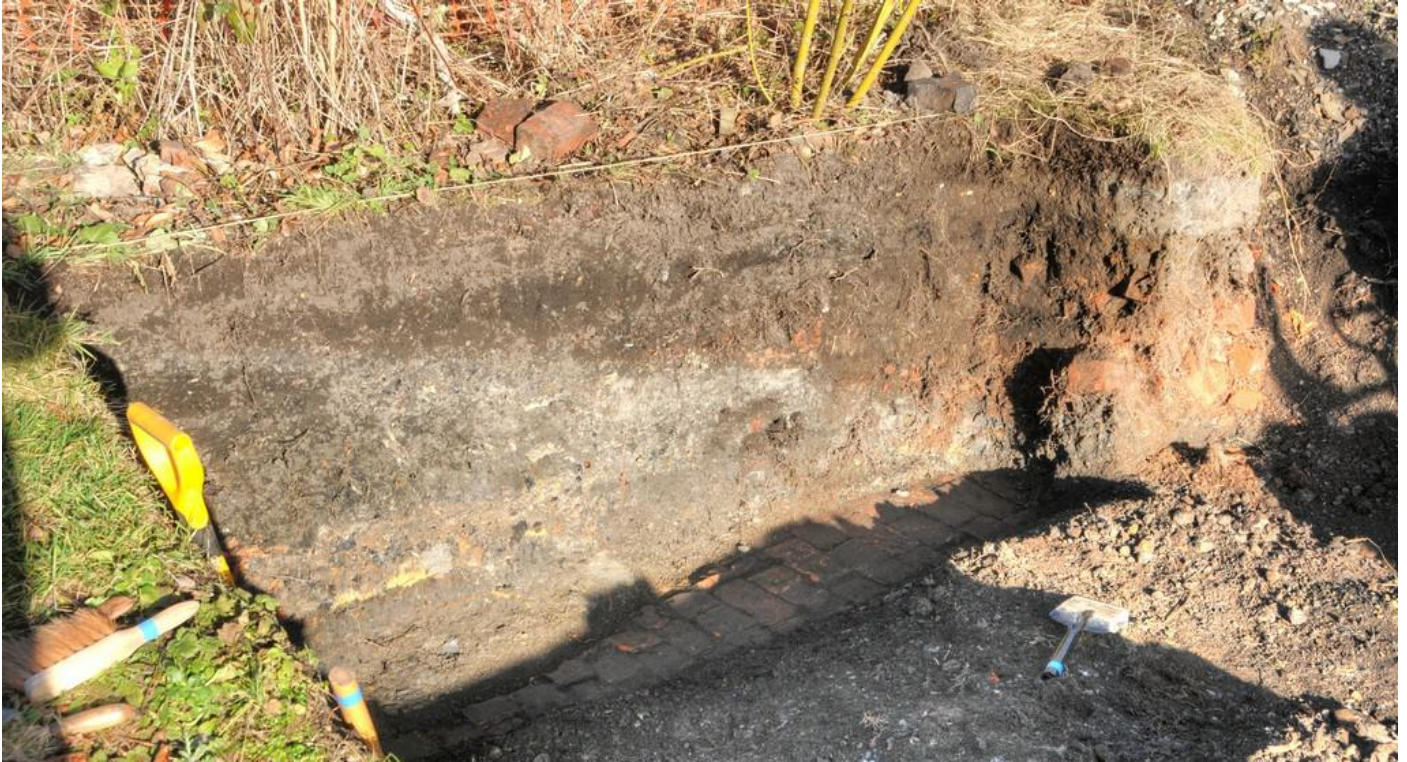
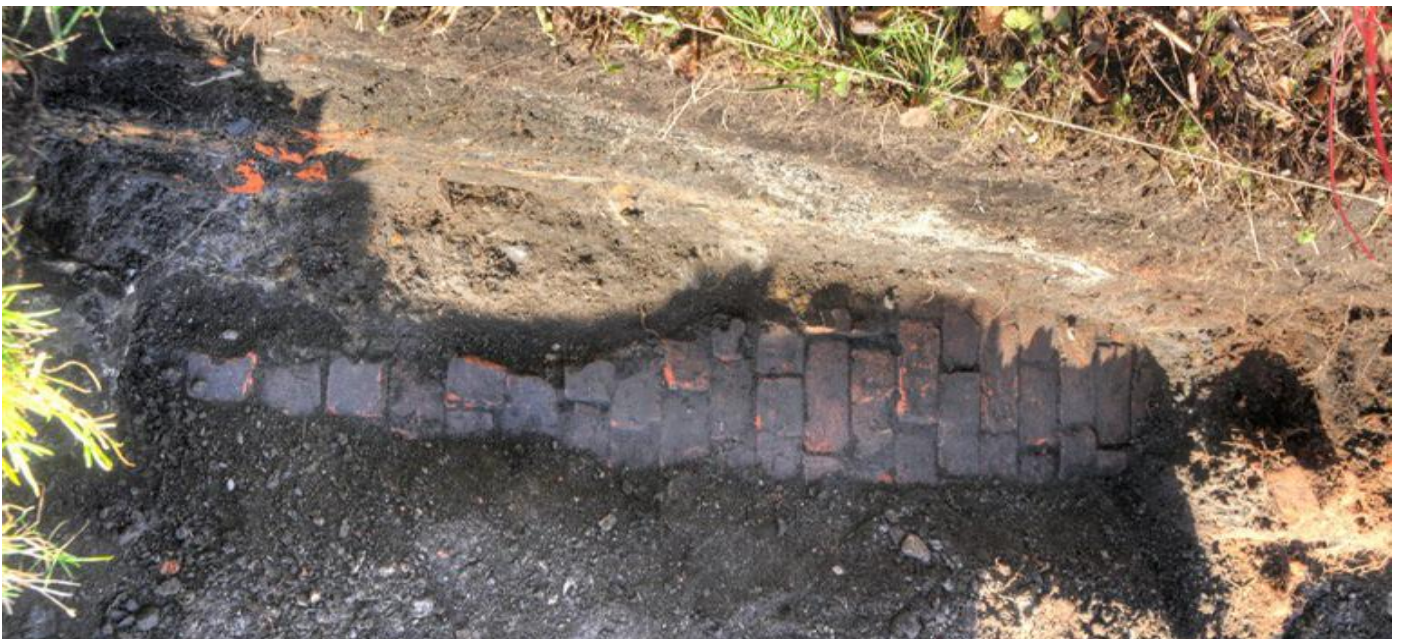
Further work was carried out at the north end of the stoke holes to confirm that there was a consistent edge to the pavement. From the shape of the edge of the brickwork there is the possibility that part of the brick pavement may extend further north than previously believed. It is possible that the brickwork was outlining a storage facility. As previously planned it is intended to dig a metre wide trench north where bricks disappear under the soil to see how far the bricks go.

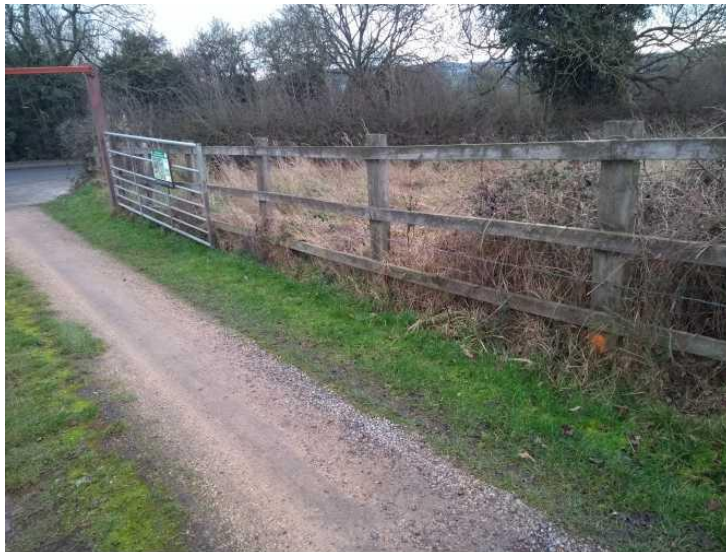
Location of Califat Tramway

Route of the Califat tramway marked on the track and spinney fence with orange paint

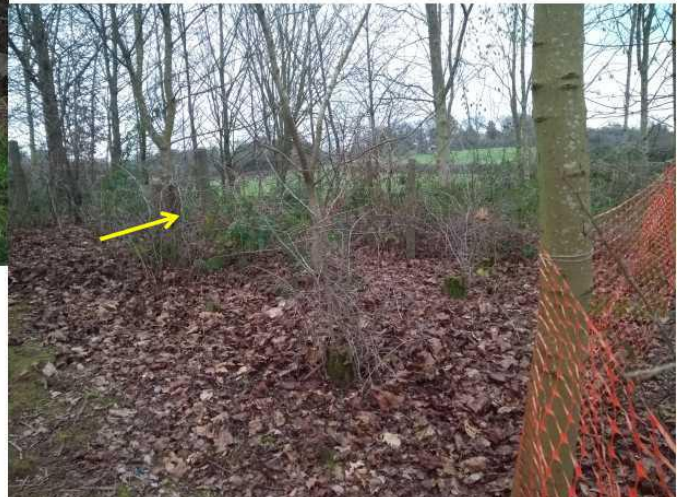
Robin used his surveying skills to work from the 1903 map to identify where the Califat tramway crossed the access track. This was marked with orange paint at the base of the posts. It appears to be very wide because the tramway has only just started turning from the road towards the mine and its route partially overlaps the track. Robin has also estimated the point where the tramway entered the current spinney, this was particularly challenging as the field boundaries are now completely different.
