## Califat Coal Mine, St George's Hill, Swannington

### Excavation and consolidation of the Califat engine house

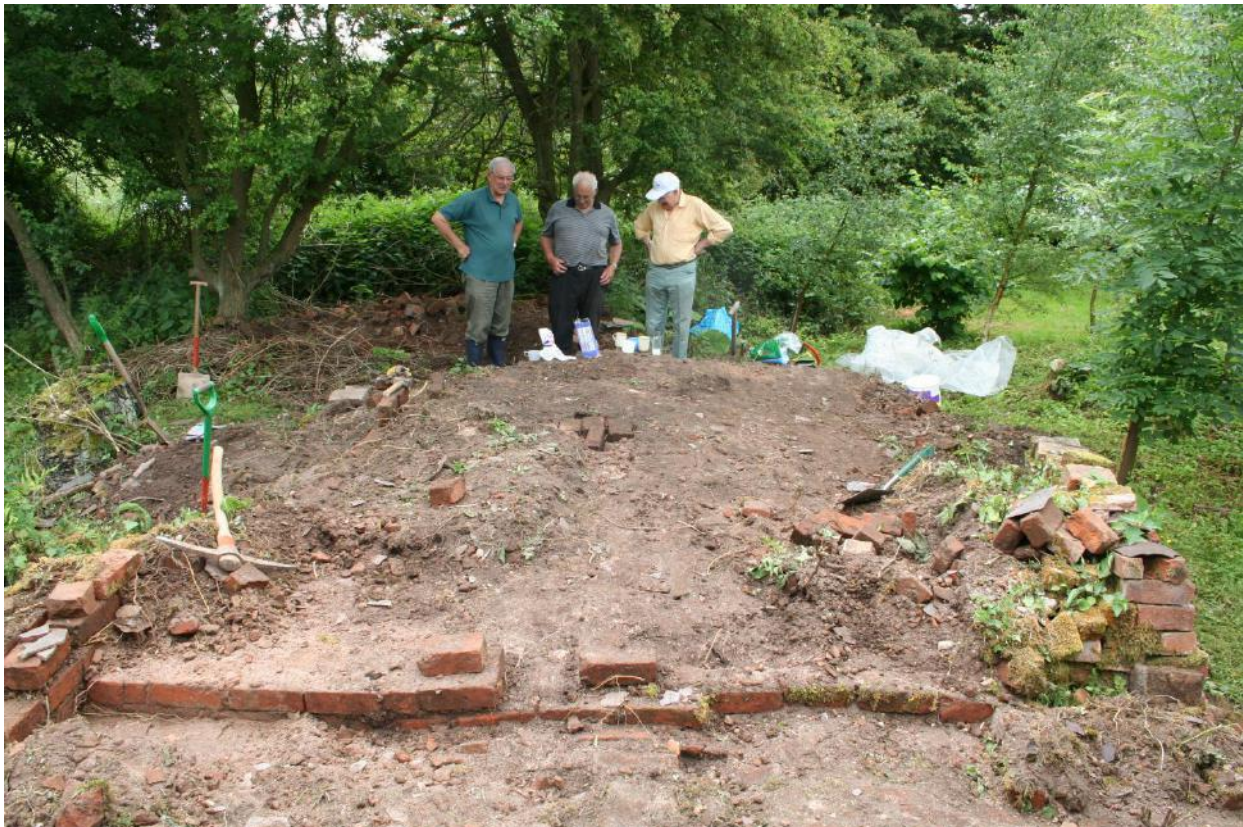
Photo 15<sup>th</sup> June 2006 by David Lyne

The excavation soon uncovered a large brick floor.

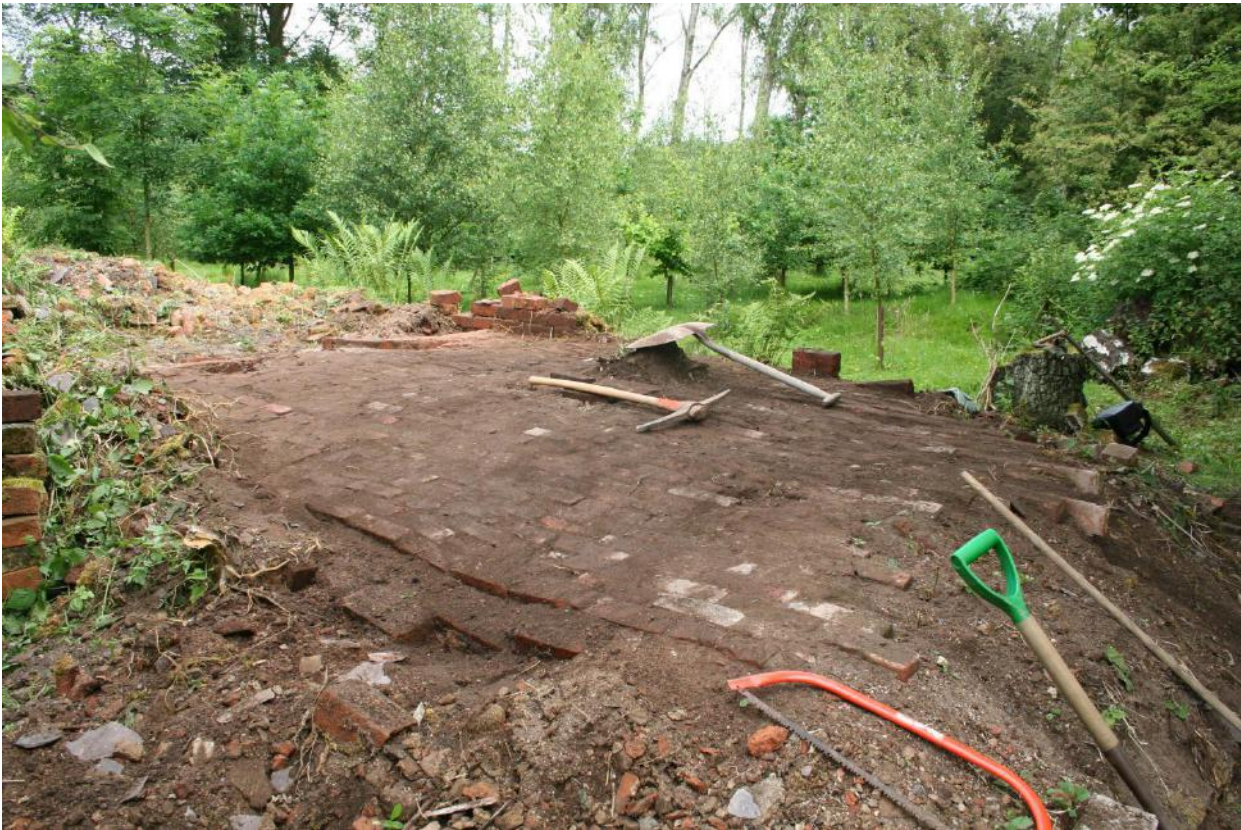
*Photo 15<sup>th</sup> June 2006 by David Lyne*

The slightly domed brick floor.

Villagers had told the Trust that Jim Curtis (who lived in the Califat cottages until they were demolished in 1958) used to have a hen house in the vicinity. Diggers explored the area around the brick floor and discovered a ventilation tunnel and other evidence of an engine house.

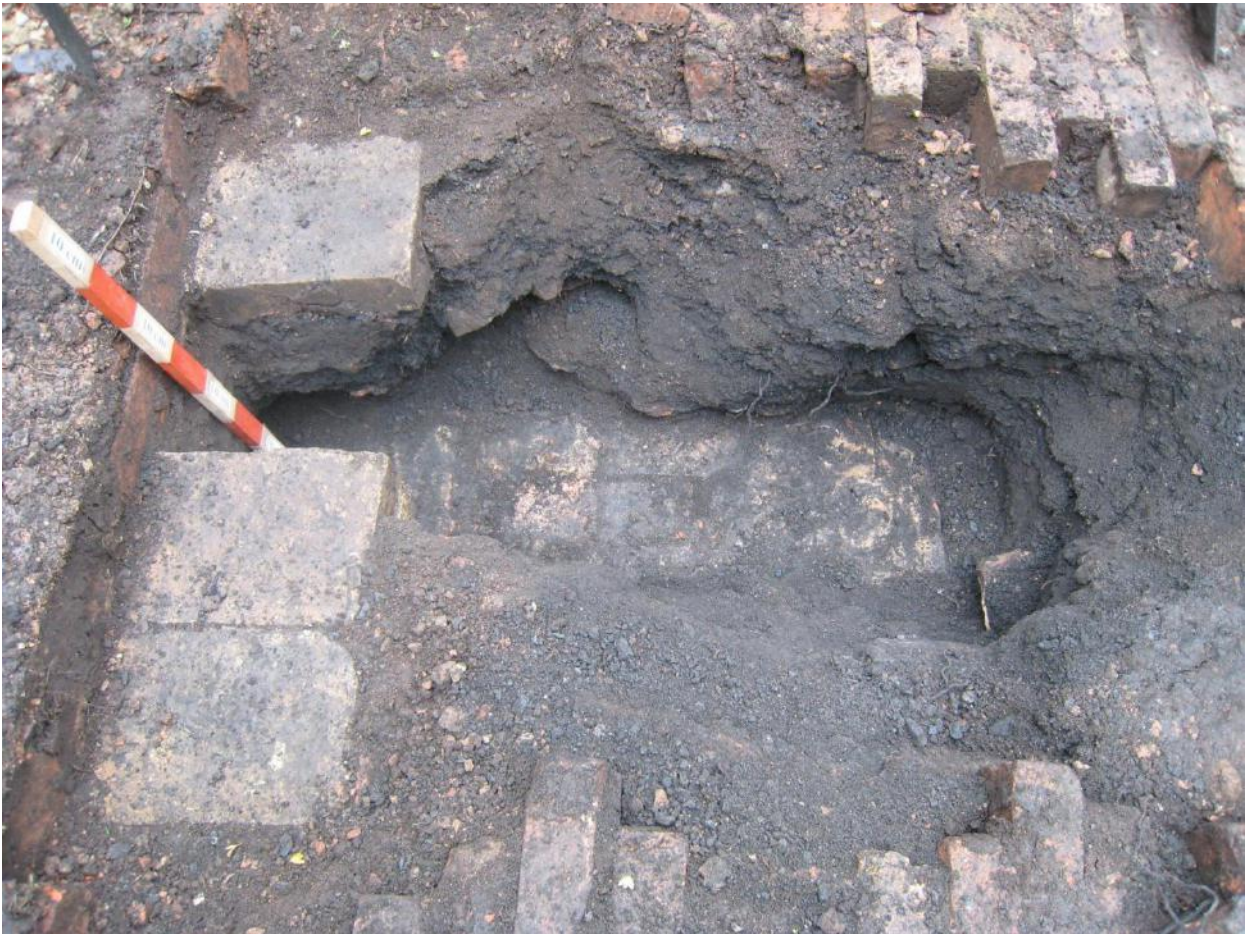
*Photo 14<sup>th</sup> August 2007 by David Lyne*

By July 2007 diggers had removed a cross-section of the hen house floor and discovered a brick structure underneath.

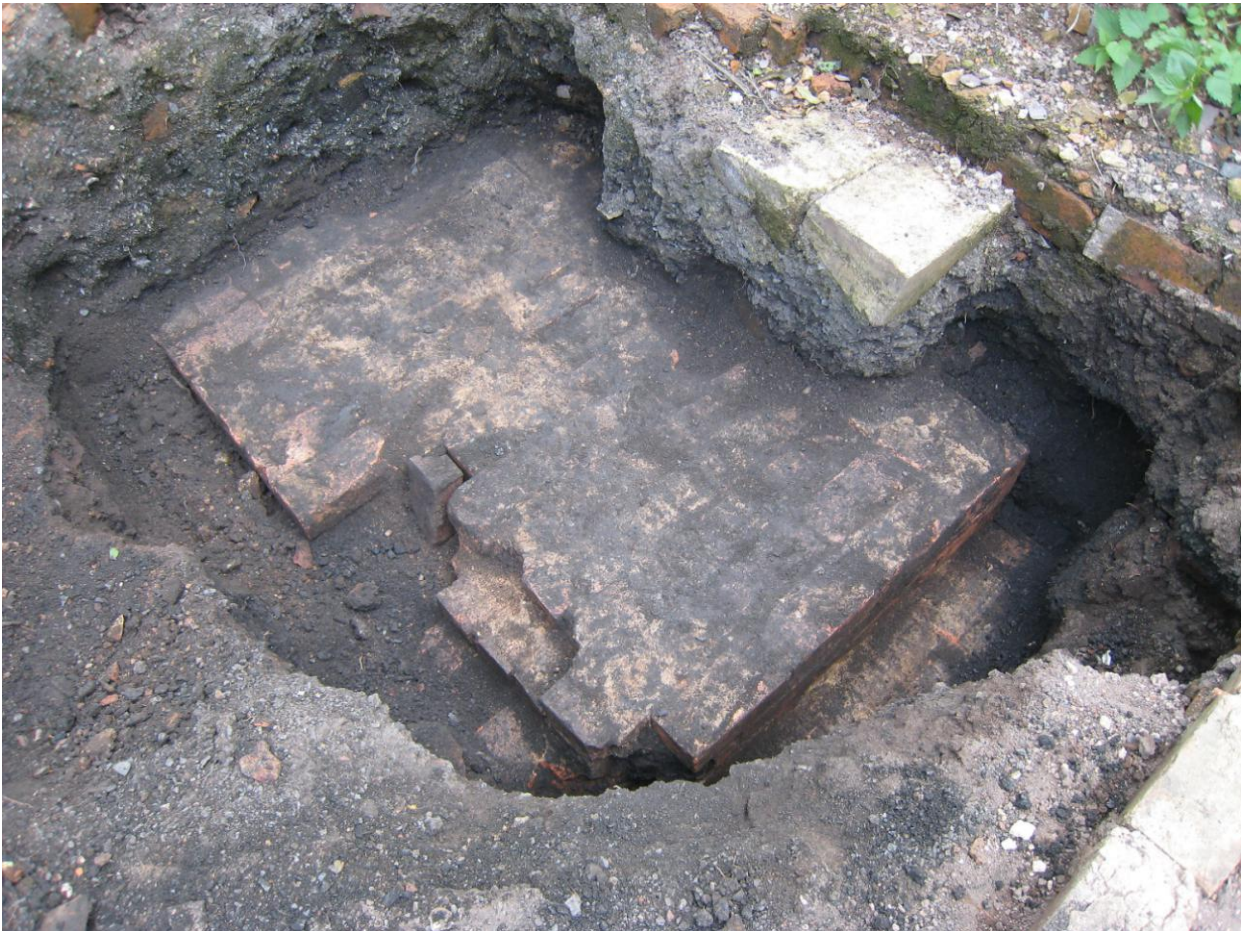
*Photo 11<sup>th</sup> September 2007 by David Lyne*

As the diggers kept digging they uncovered more of the hidden brick structure.

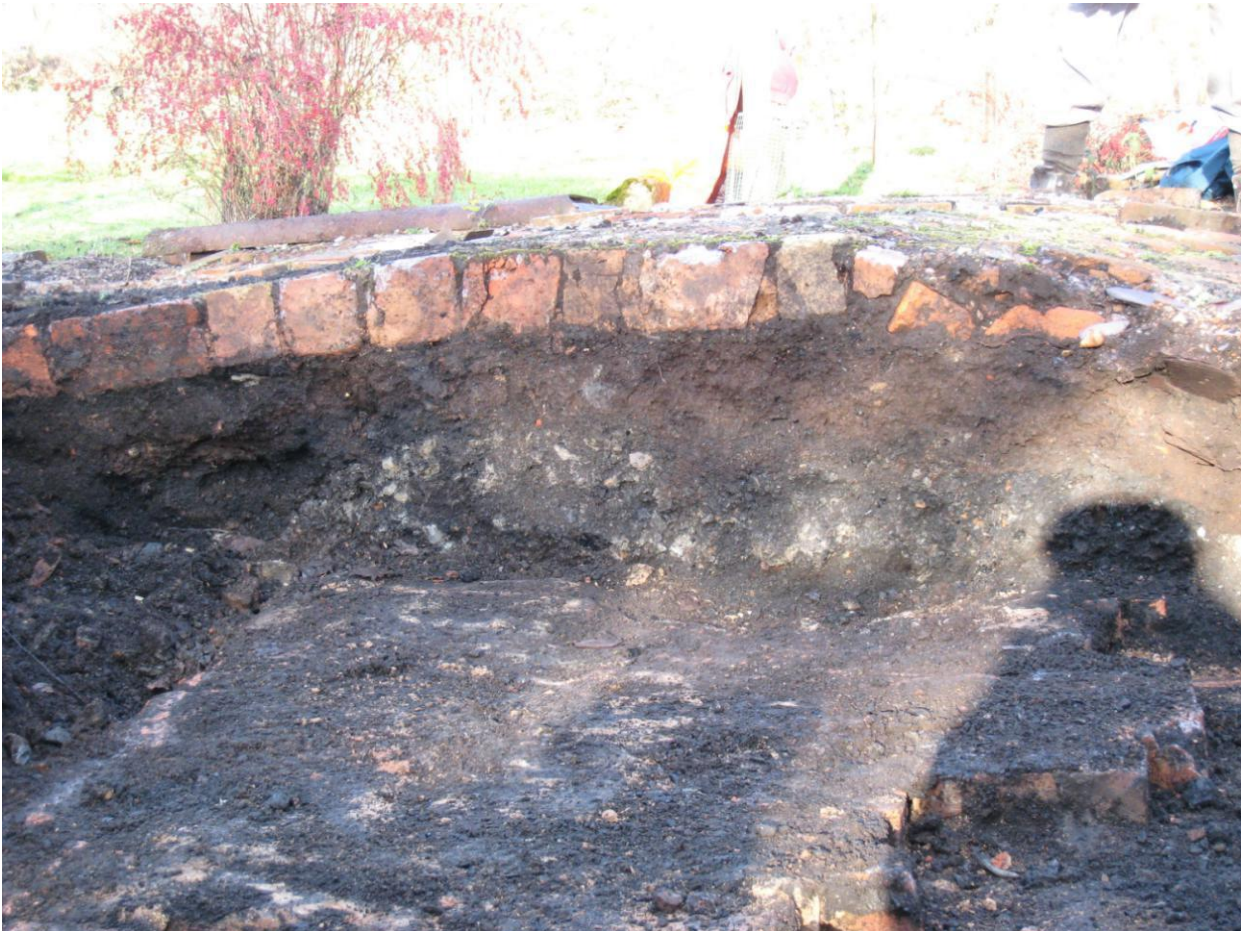
*Photo 11<sup>th</sup> December 2007 by David Lyne*

By December 2007 it was possible to see that layers of clay and mining spoil had been laid on top of the lower brick structure. These were topped with the domed floor of the hen house.

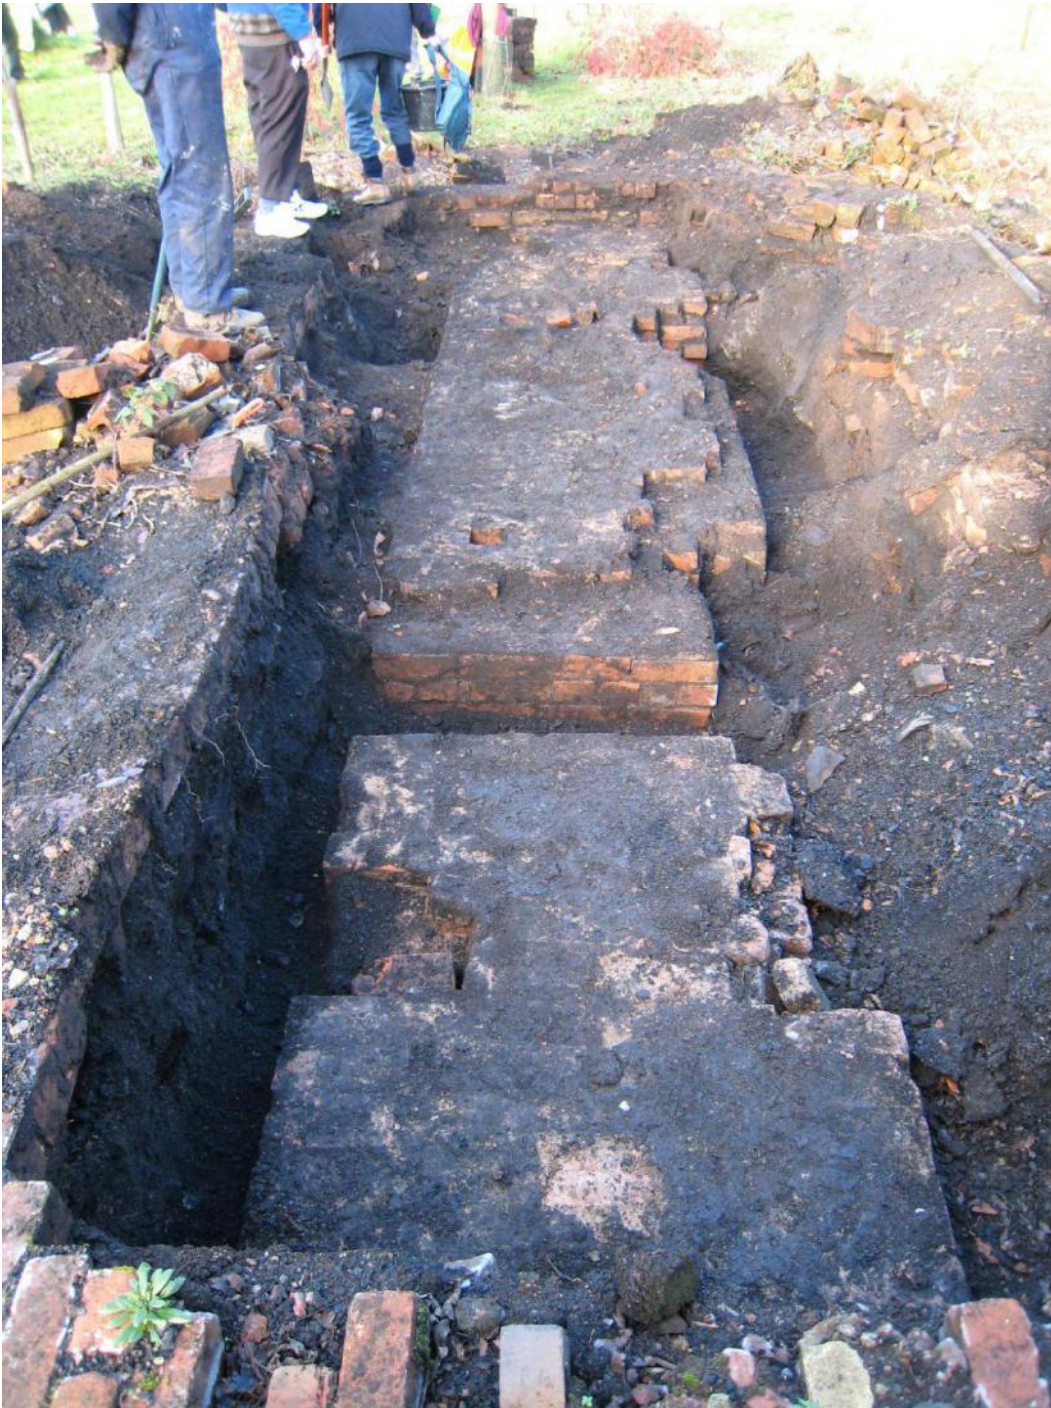
*Photo 11<sup>th</sup> December 2007 by David Lyne*

What appeared to be two brick plinths were uncovered by December 2007.

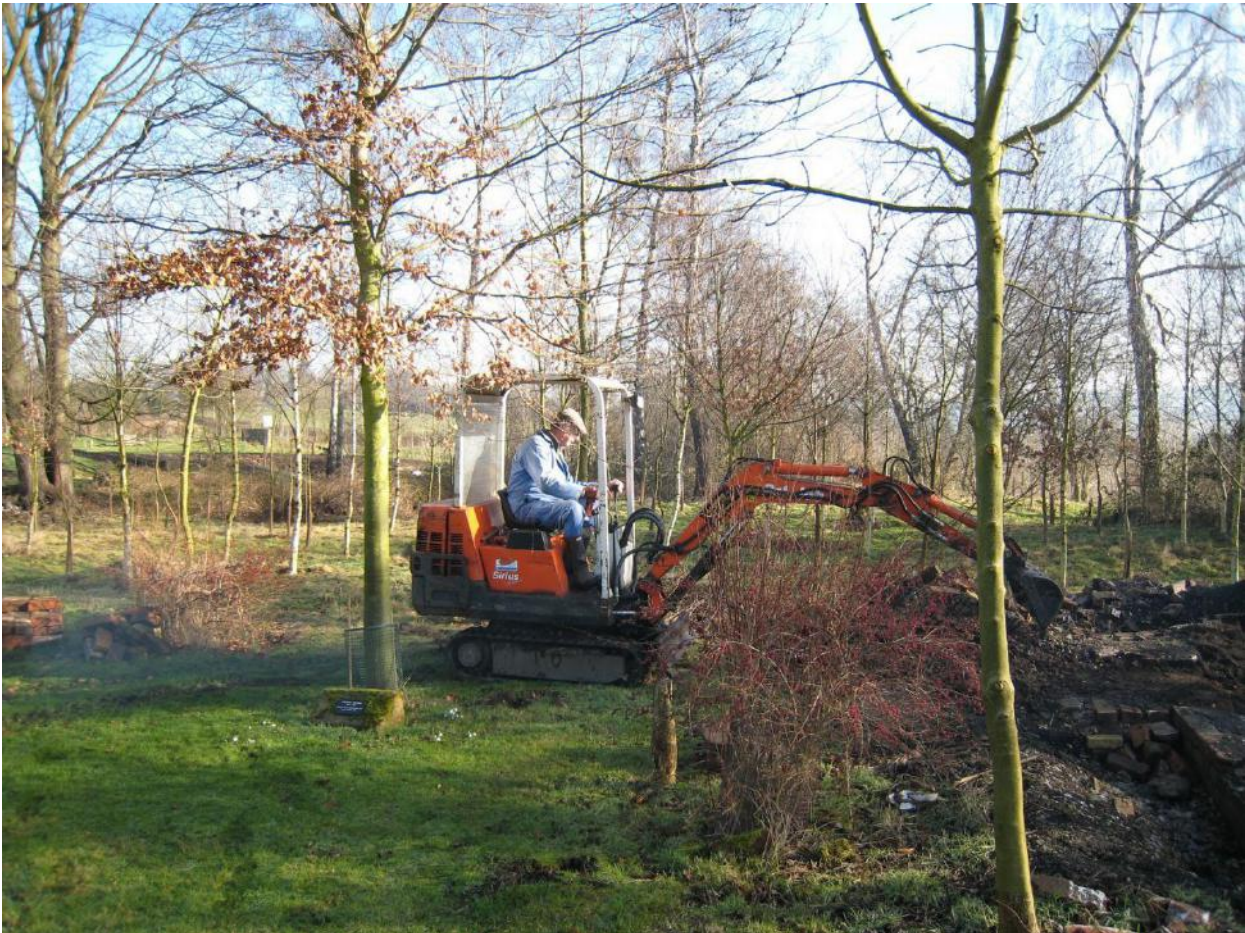
*Photo 12<sup>th</sup> February 2008 by David Lyne*

In February 2008 LIHS used a mini-digger to carefully move large volumes of material from around the brick structures.

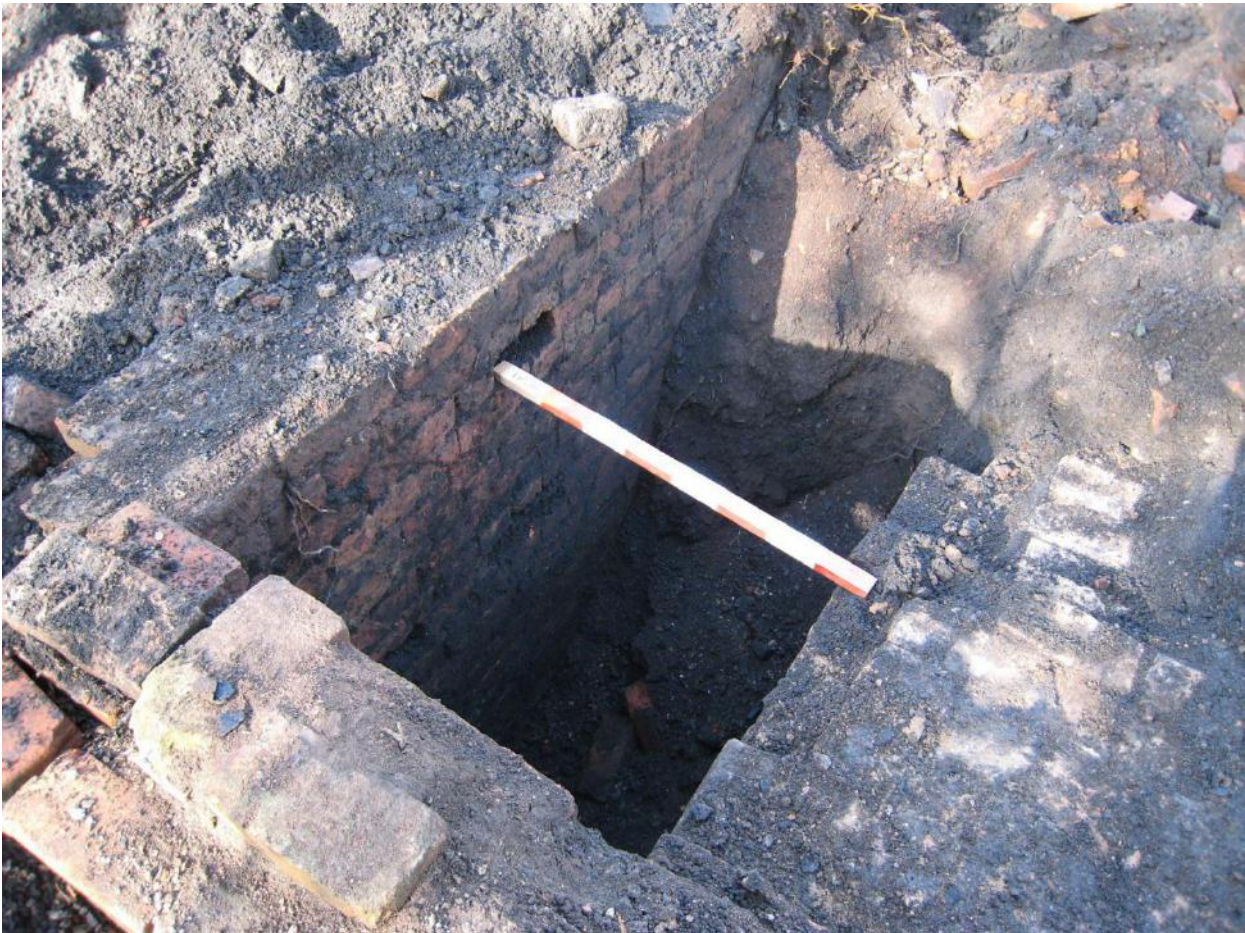
*Photo 12<sup>th</sup> February 2008 by David Lyne*

The mini-digger dug out a void (approx 2ft or 70cm wide) between the plinth and the surrounding wall.

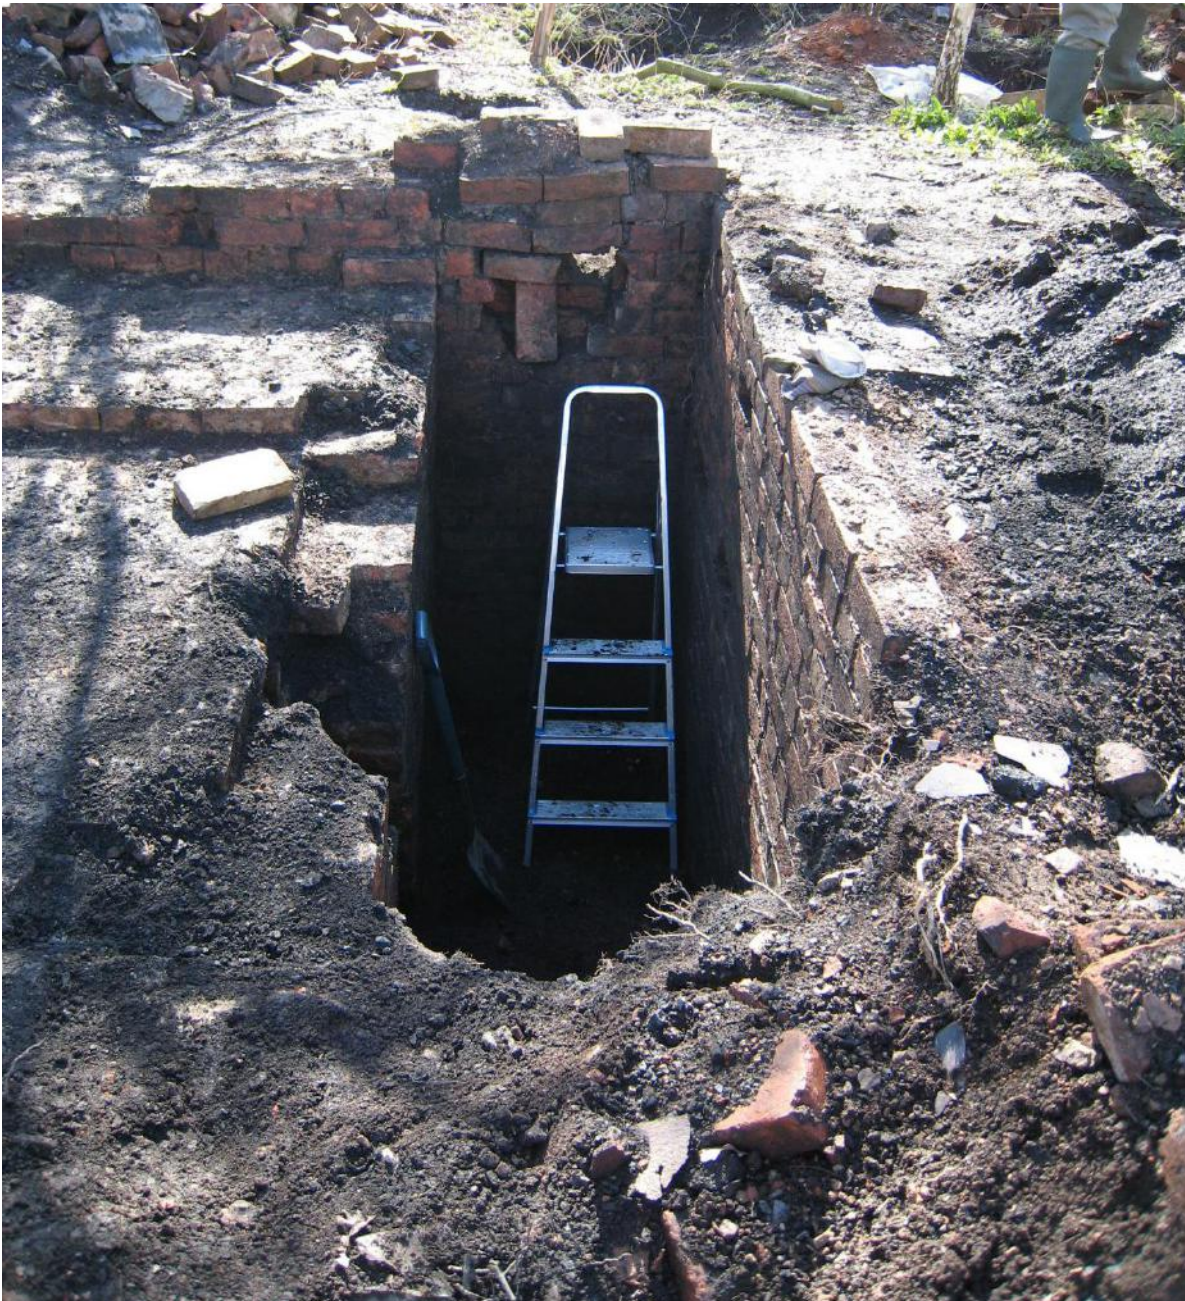
*Photo 11<sup>th</sup> March 2008 by David Lyne*

The void was about 6ft 6in or 2m deep and required a ladder to descend and ascend in safety.

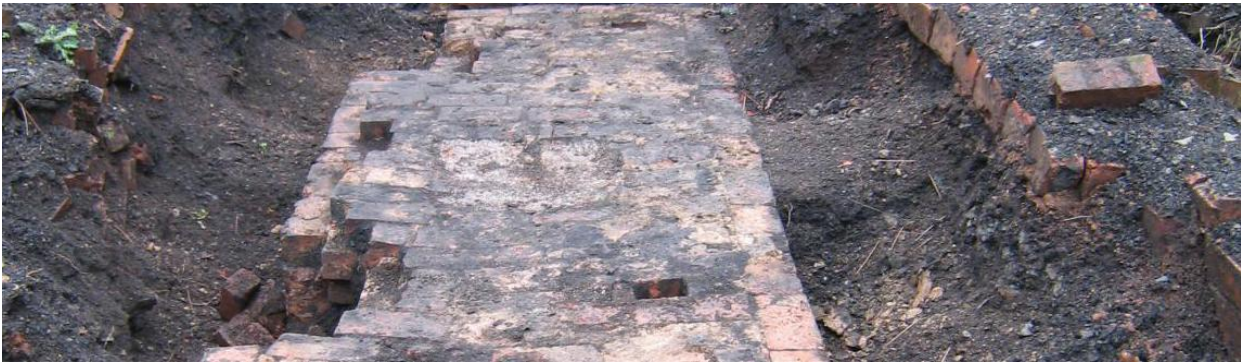
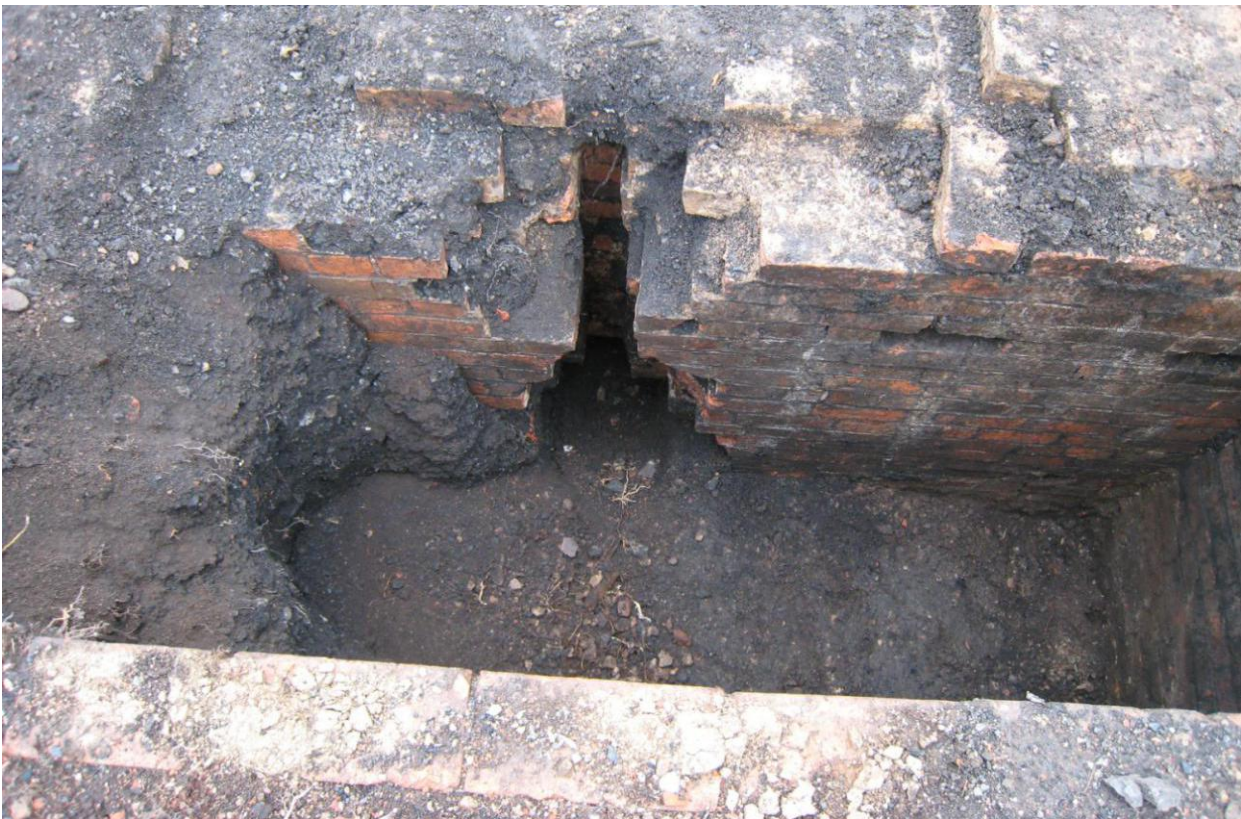
*Photo 11<sup>th</sup> March 2008 by David Lyne*

The plinths had deep, square holes. Some were damaged and the line of the hole descending to the bottom of the plinth could be clearly seen.

It is believed that an engine stood on each part of the plinth and the square vertical holes were for the engine holding down bolts. Horizontal “rag holes” at the bottom of the void enabled locking bars to be inserted into the bottom of the holding down bolts to keep them in place.

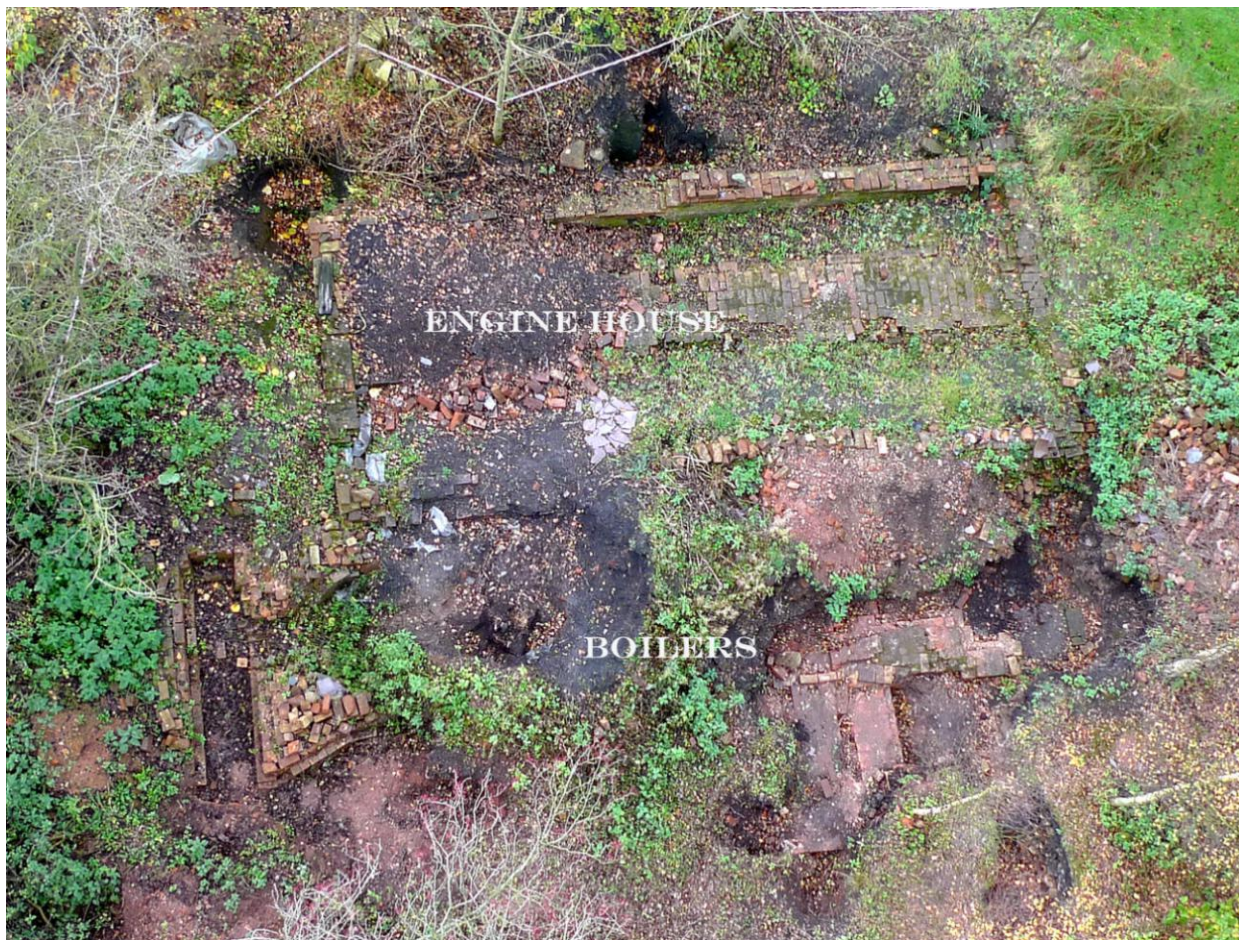
*Photograph November 2009 by David Lyne*

This November 2009 photograph shows the progress of the overall excavation. The engine house is at the top, the boiler house towards the bottom and the flues leading to the chimney are bottom left.

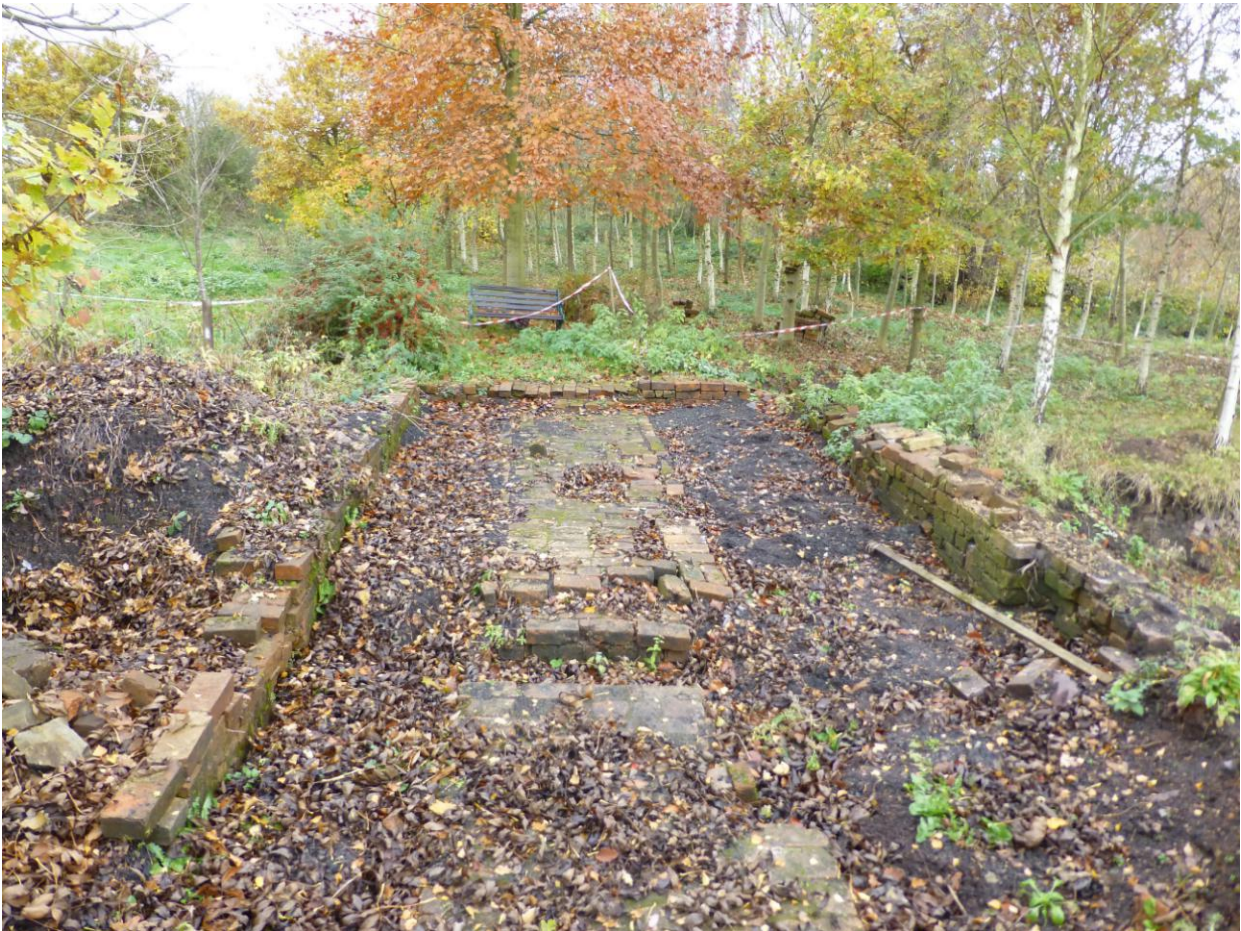
*Photo 13<sup>th</sup> November 2012 by David Lyne*

LIHS excavation work continued to focus on the boiler house and ventilation tunnels. Nevertheless in November 2012 (allowing for the leaves) the plinth and engine house walls could be clearly seen. Diggers had filled in the voids between the plinth and engine house walls after recording their details, thereby eliminating a safety hazard for visitors.

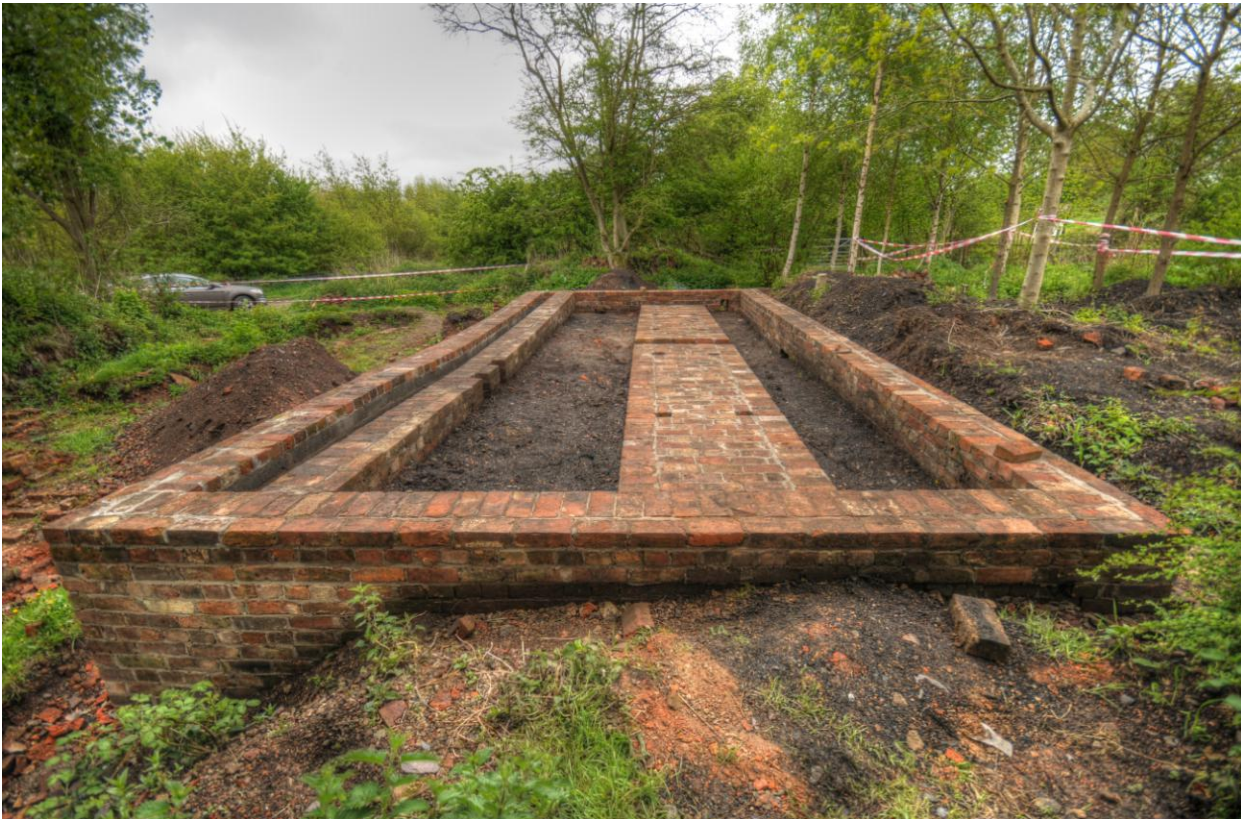
*Photo 18th May 2013 by Bill Pemberton*

Consolidated engine house looking south from the copper beech tree towards the track.

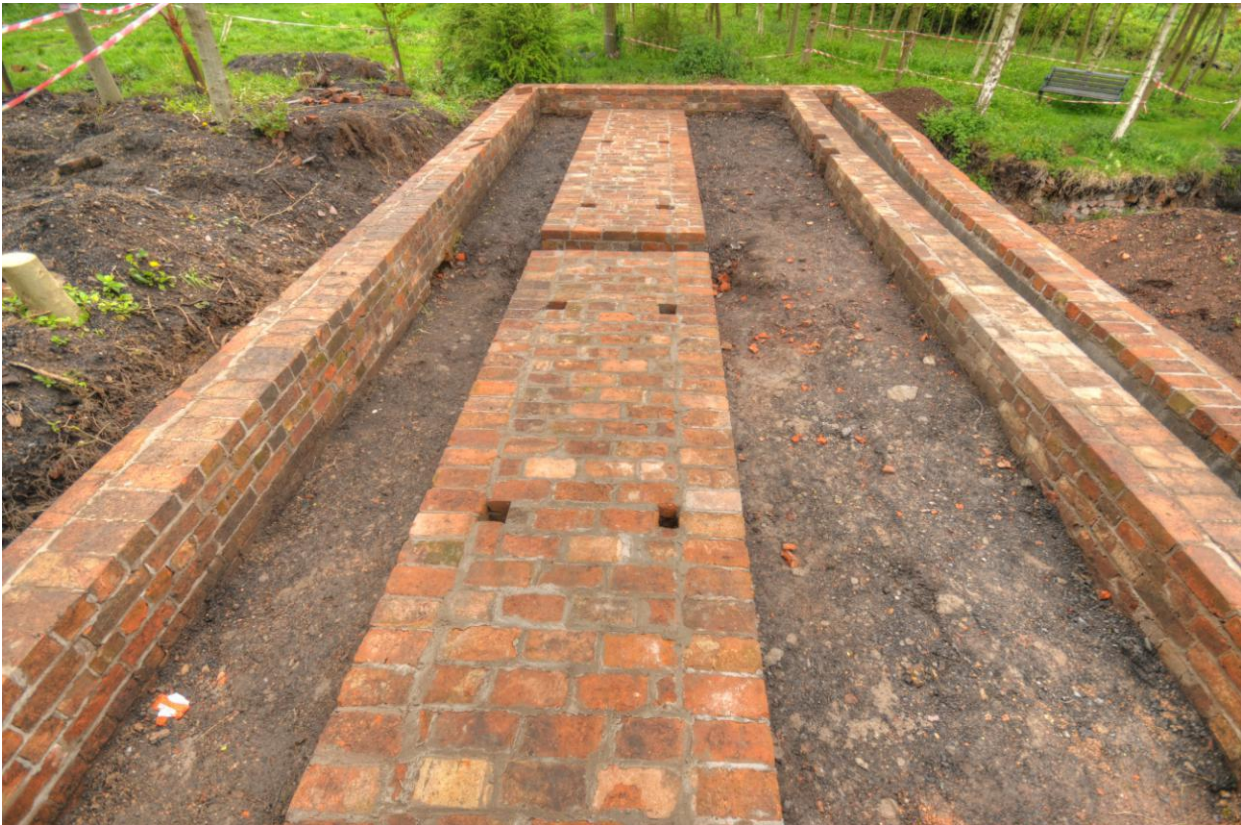
*Photo 18th May 2013 by Bill Pemberton*

Consolidated engine house looking north towards the woodland. The two pairs of holding down bolt holes on each part of the engine plinth can be clearly seen.

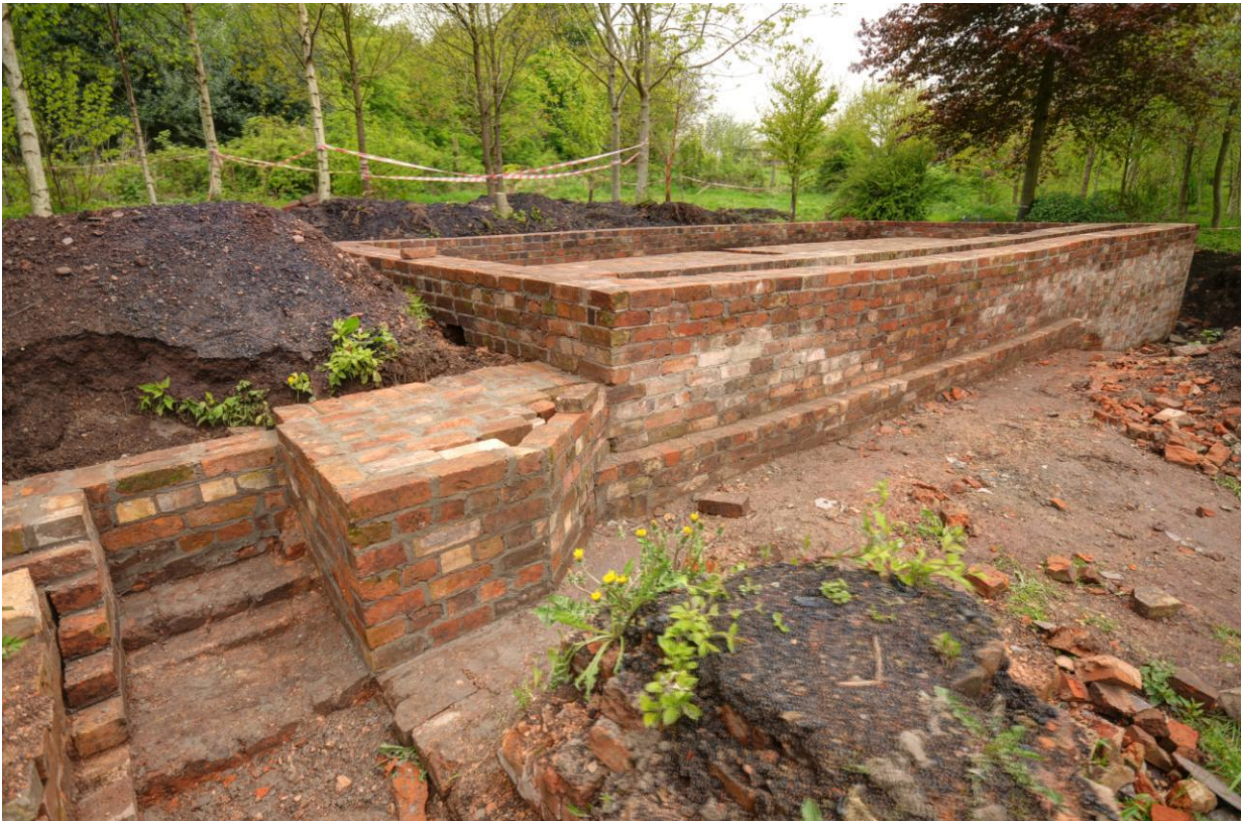
*Photo 18th May 2013 by Bill Pemberton*

Consolidated engine house view from the chimney area.
