Fantail Drive Mechanism

Replacing the Curb Drive Pinion

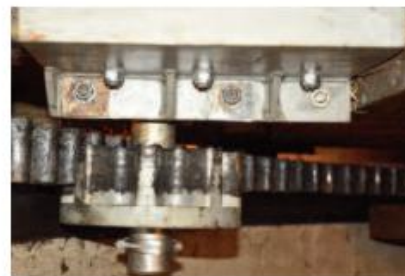
The coach bolts on the pinion shaft lower bearing bracket had sheared or were loose. The team had to fabricate a beam supporting bracket and fit studs through the wooden beam to hold the bearing in place.

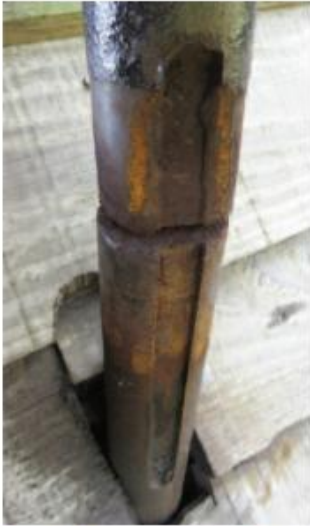
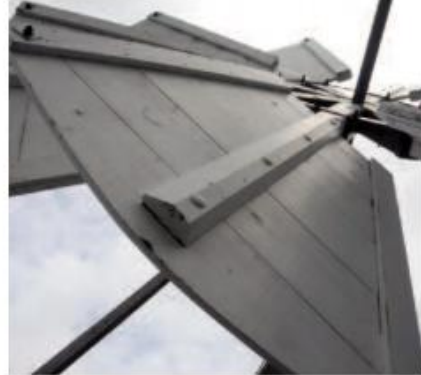
The team wanted to check that over a number of sessions the cap rotated a full circle. However on Friday mornings the wind tended to blow from the same one or two directions.

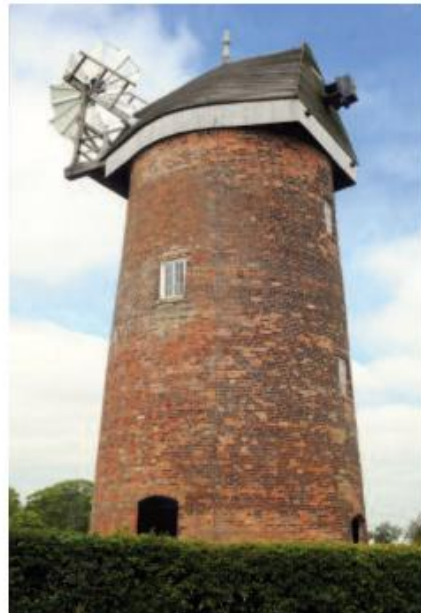
After more than a year of intermittent work, the fantail sails were fully operation and the fantail drive was again turning the cap when the wind changed direction.
