Monthly dig report for members of Leicestershire Industrial History Society and Swannington Heritage Trust.

Red Cinders Pile Area

Engine House near Califat Shaft - Excavation 2006-2017

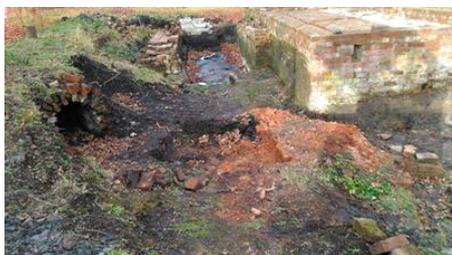
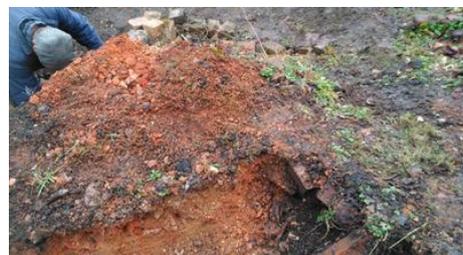
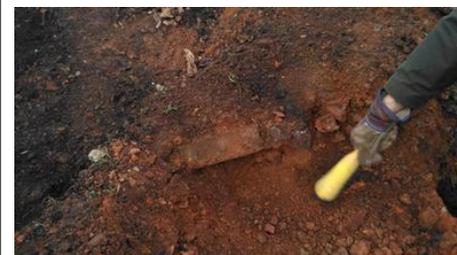
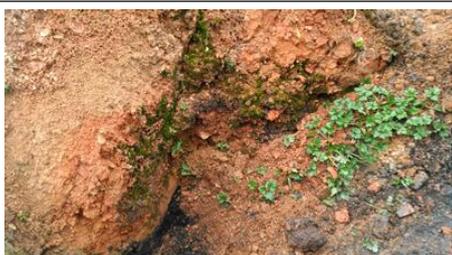
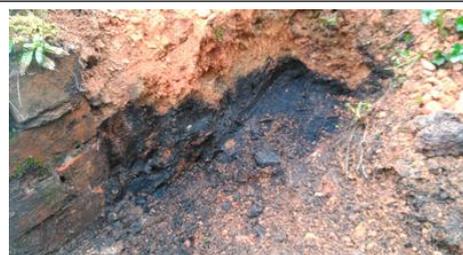
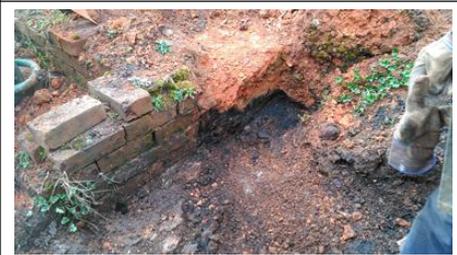
The pile of red cinders was moved slowly and carefully to ensure that any evidence of the area's origins was retained. There was a small number of clean bricks in the red cinders. Under the red cinders there was a thin layer of grey material then a deeper layer of black coal dust with small pieces of coal. Possible explanations for the three layers of material are:

- 1 A surface furnace for furnace ventilation. This is based upon the ash being between the tunnels and the chimney. However there is as yet no evidence of any structure that could have been the furnace and the size of the tunnels may be too small. Perhaps a furnace would be nearer to the the shaft.

- 2 Ash dumped from the boilers. However the boiler holes for stoking and cleaning are around the other side of the engine house, so its not very likely anyone would bring the ash all the way around the boilers and chimney or round the engine house.

- 3 A brick making operation as the ash contains some new and very clean bricks. Hoverer the size of the ash heap and the locations indicate that the operation would have been far too small to be viable.

- 4 Spontaneous combustion of coal dust and small pieces of coal. This seems most likely as there is coal dust under and to one side of the ash and the boundary between the ash and coal dust is distinct indicating that the boundary is where the combustion ran out of heat, leaving the coal unburned. The perfectly preserved brick could have been new ones discarded by builders (as they do today, see any building site) that fell into the the coal dust and then got partially refired and preserved in the ash.

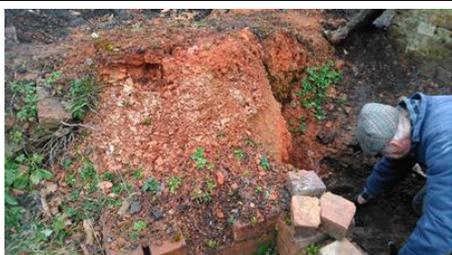
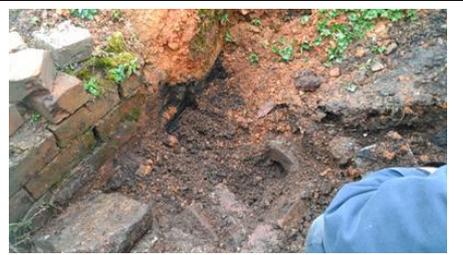
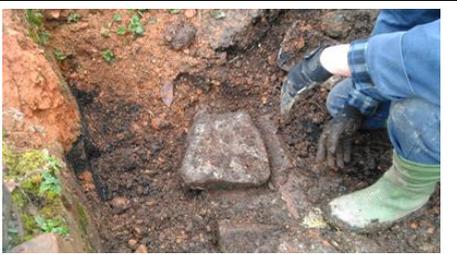
The area next to the bricked off tunnel was carefully cleared to reveal the drain. The drain pipe was covered with a large stone.

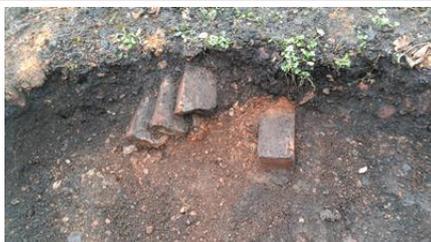
Between the red cinders and the exposed chimney there was evidence that part of the tunnel had collapsed under a heavy weight. This could have been from a horse and cart or heavier 20th century machinery.

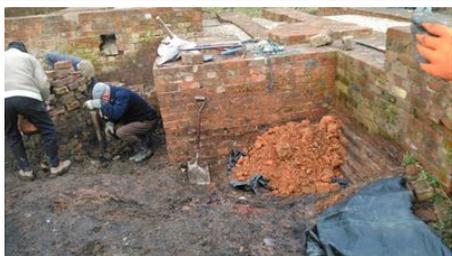
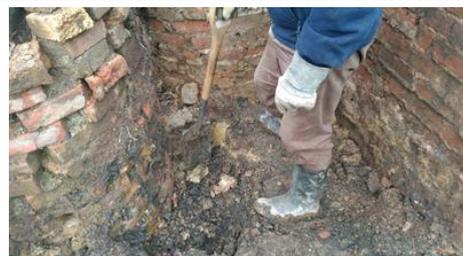
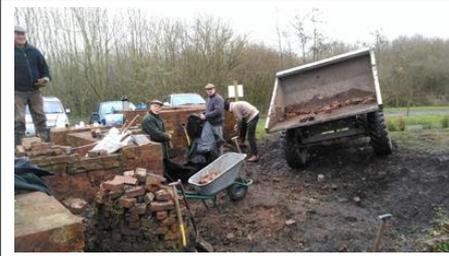
South of the engine house more of the clay was dug out of the area around the bbq, bringing the dumper truck close (but not anywhere it would damage the excavation) helped with the removal of material. The pile of red cinders to the west was moved onto a membrane in the corner of the boiler house and chimney, thus providing an option to return it after the cinder area has been fully excavated.

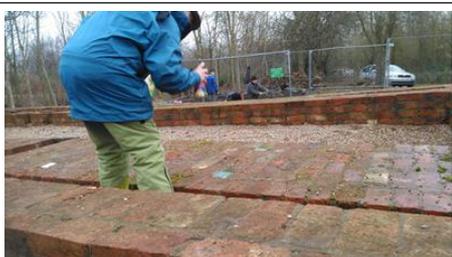
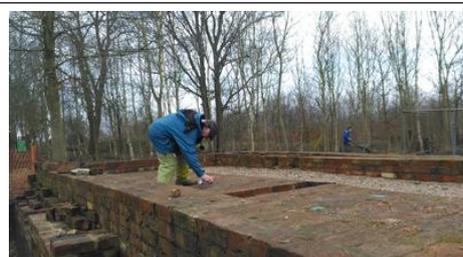
We were a bit concerned about the smell - was it a suspicious gas? Then we spotted the cause, a dodgy guy reliving his youth with a spray can. But as he only painted the white foam (covering the holding down bolt holes) green, we left him to it.

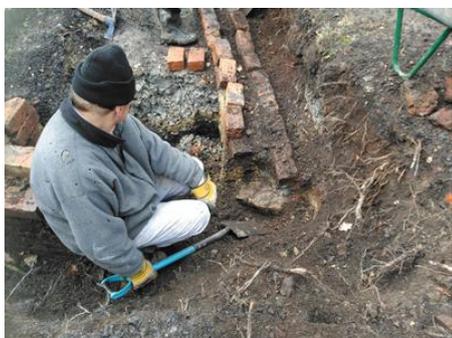
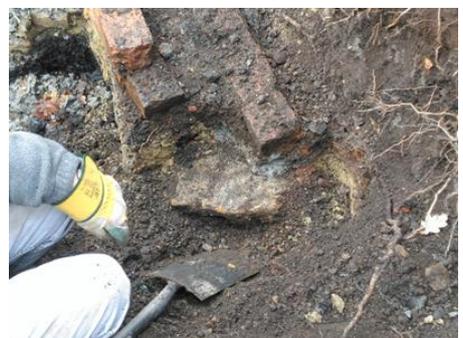
Old Shaft to East of Califat Boiler House

The eastern end of the north wall was built on a large stone, the rest of the wall was built on clay.
Deliberate or just happened to have a large stone handy.
Further east the wall did not extend into the area formerly occupied by the oak tree.

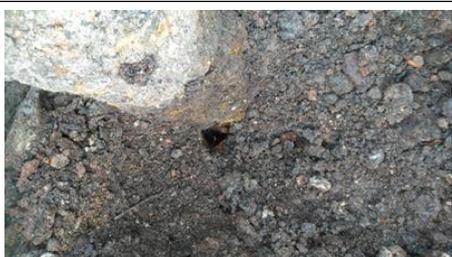
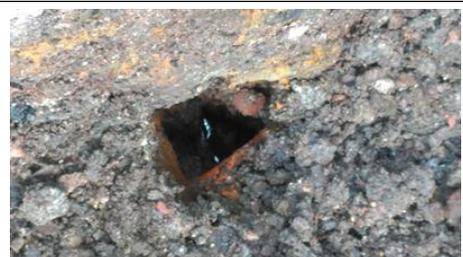
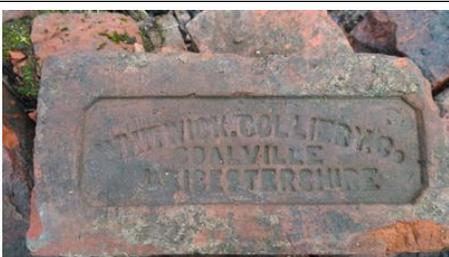
Digging out the area around the (water?) pipe we identified a small hole, possibly leading to some form of chamber.

Whitwick colliery Co, Coalville, Leicestershire - would be good if we could date the brick.

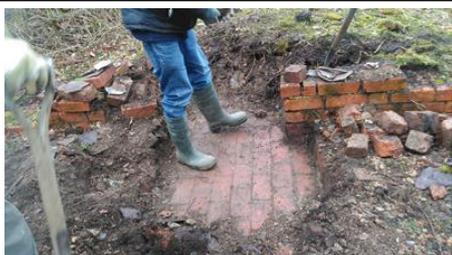
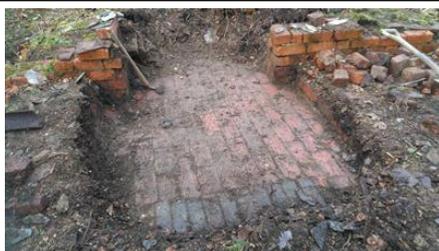
Miners' Cottages

The loose jumble of bricks and other material in what was found to be the porch doorway were removed.

The floor of the porch at the front of the cottage was revealed. It is possible that the floor tiles were added at a later date.

The porch walls were also visible.

Alan used a sophisticated set of improvised instruments to determine that the floor level of the porch was 6.5 inches (16.5cm) higher than the floor or pavement to the left.

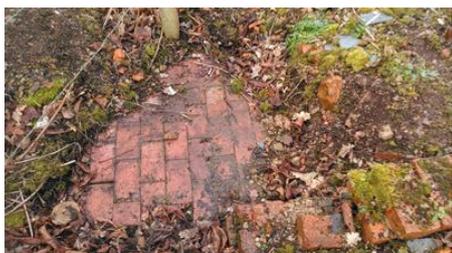
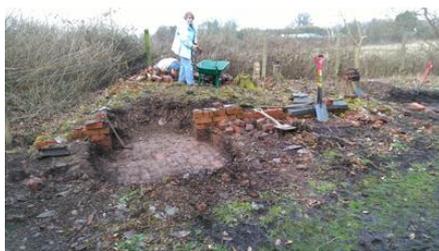
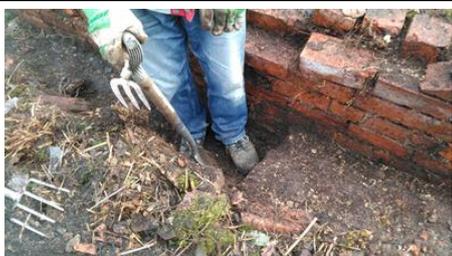
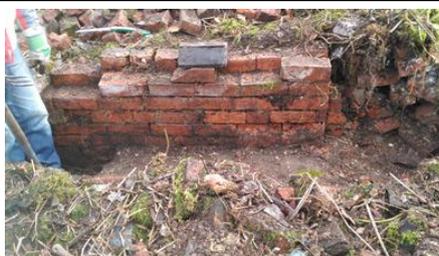
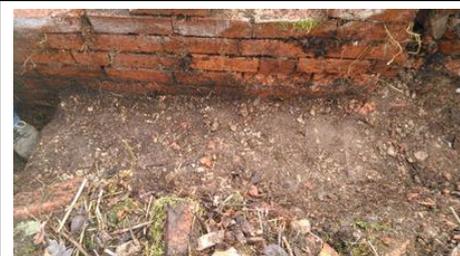
There was also progress at the rear of the cottages working along the north wall. A stepped pavement has been revealed.

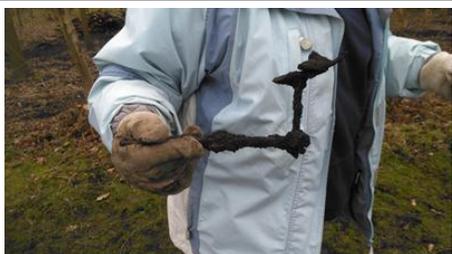
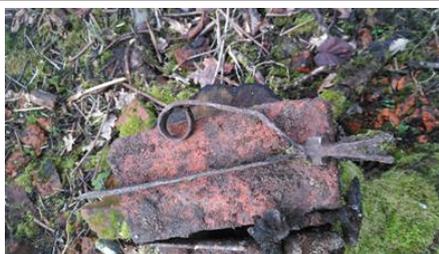
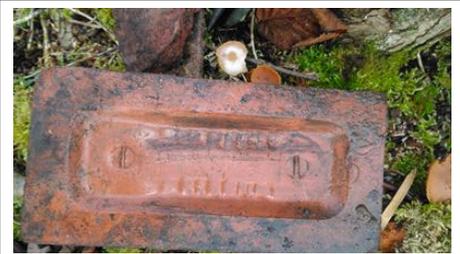
A couple of metal brackets were found. The centre photo shows how the rusting process has pushed the two right hand pieces apart. The brick is marked Whitwick Colliery.
